### *Upper East Patterson Creek Geomorphic Assessment*

## Rizmi Property City of Vaughan, Ontario

### Upper East Patterson Creek Geomorphic Assessment

Prepared by: GEO Morphix Ltd.

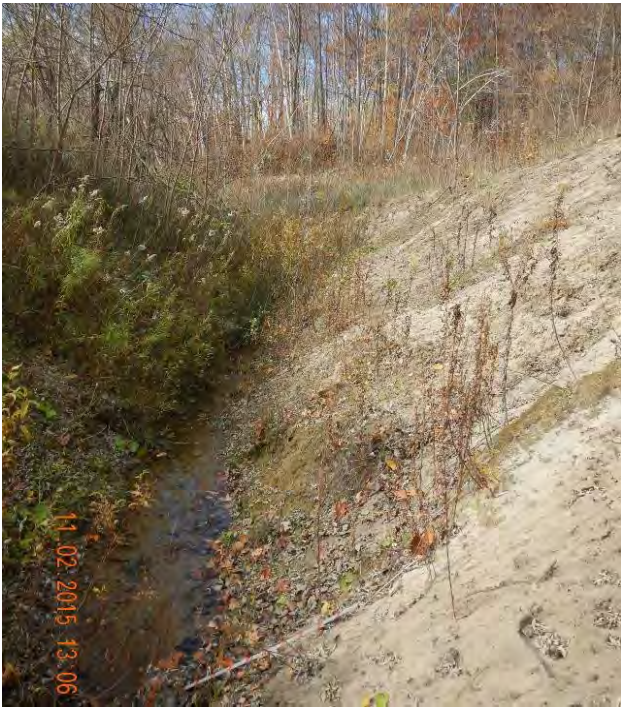
<p>Photo 1</p>

<p><b>EPC-3:</b> Near upstream extent of reach, viewed upstream. The channel was confined by sandy valley wall to the east and a vegetated valley wall to the west.</p>
<p>Photo 2</p>

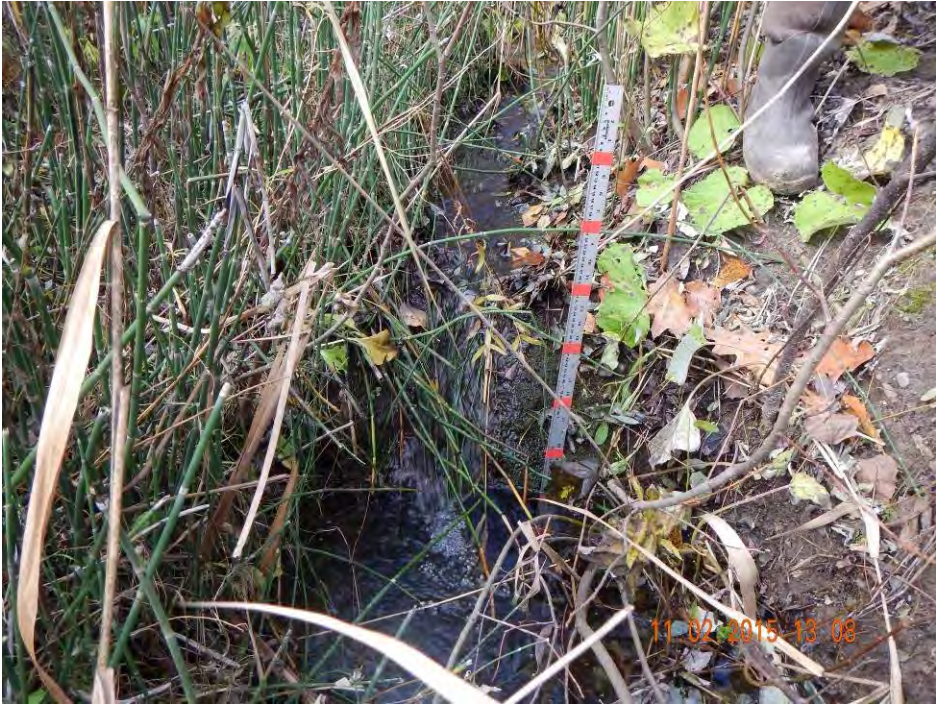
<p><b>EPC-3:</b> Mid-reach viewed upstream at a knickpoint.</p>

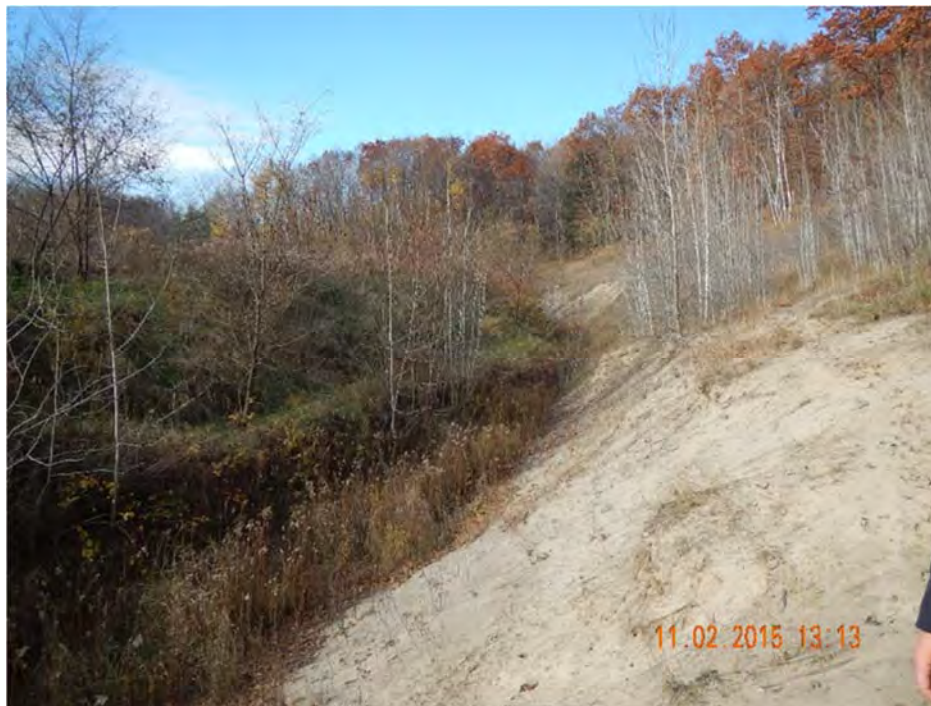
Photo  
3

**EPC-3:** Reach viewed upstream from downstream end of reach.

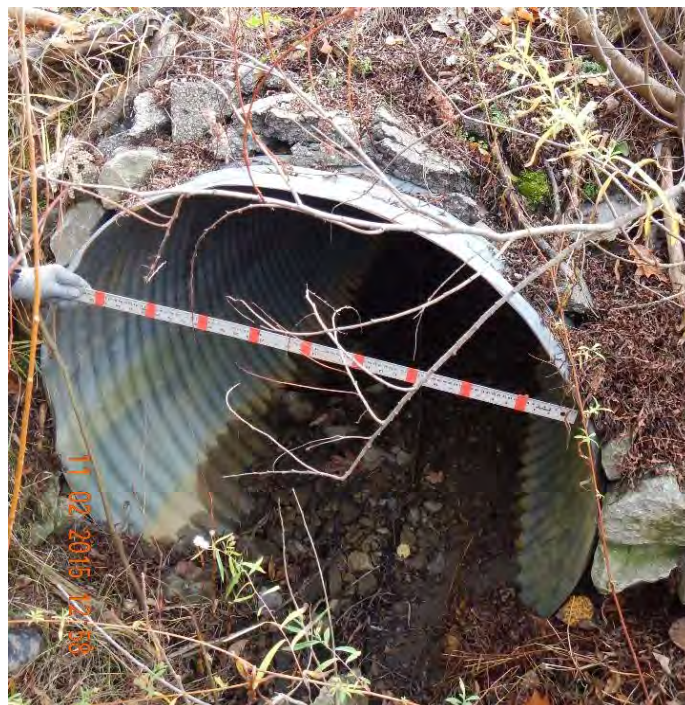
Photo  
4

1200 mm CSP culvert between Reaches EPC-2 and 3.

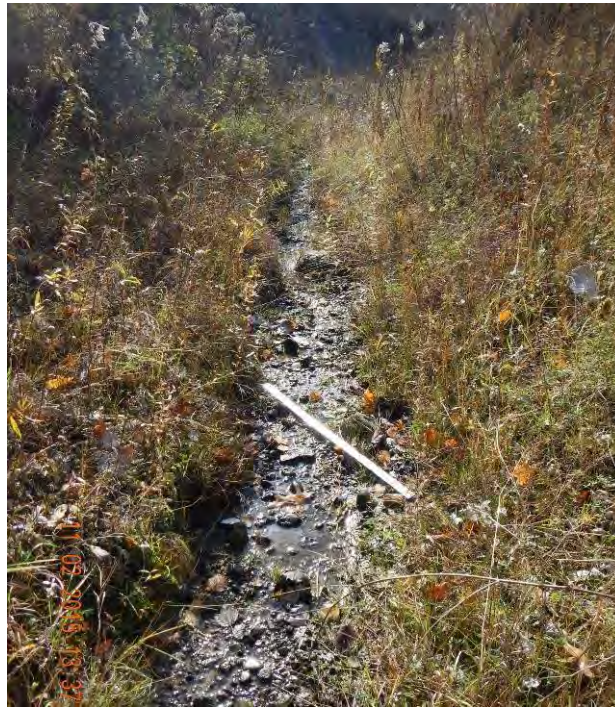
Photo  
5

**ECP-2:** Channel viewed in the downstream direction. Coarse substrate was found mostly in the upstream portion of the reach. Note the channel confinement.

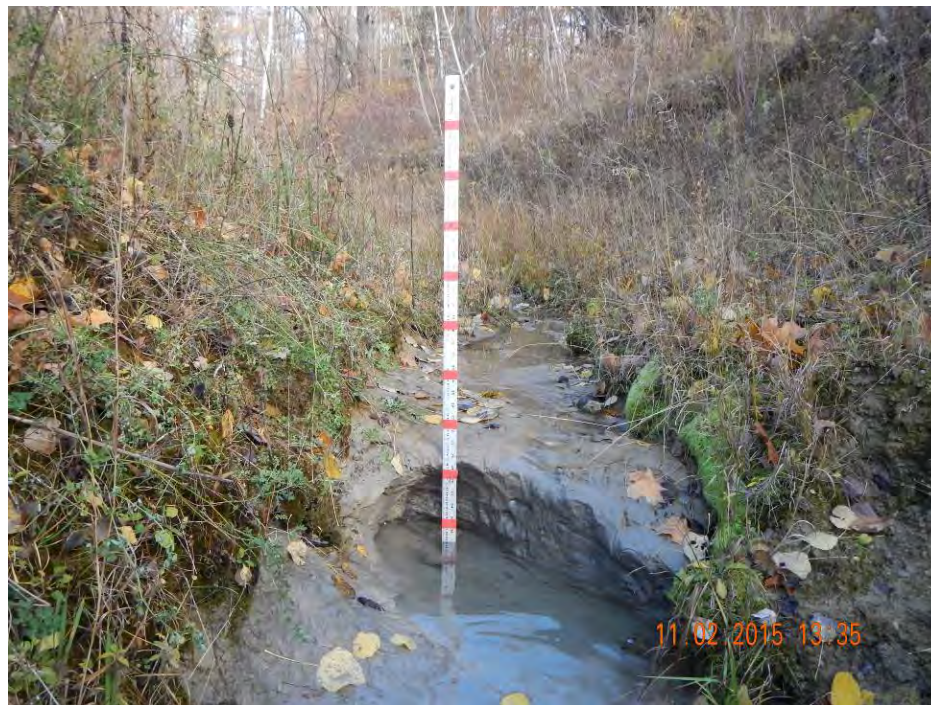
Photo  
6

**EPC-2:** Mid-reach knickpoint in exposed till.

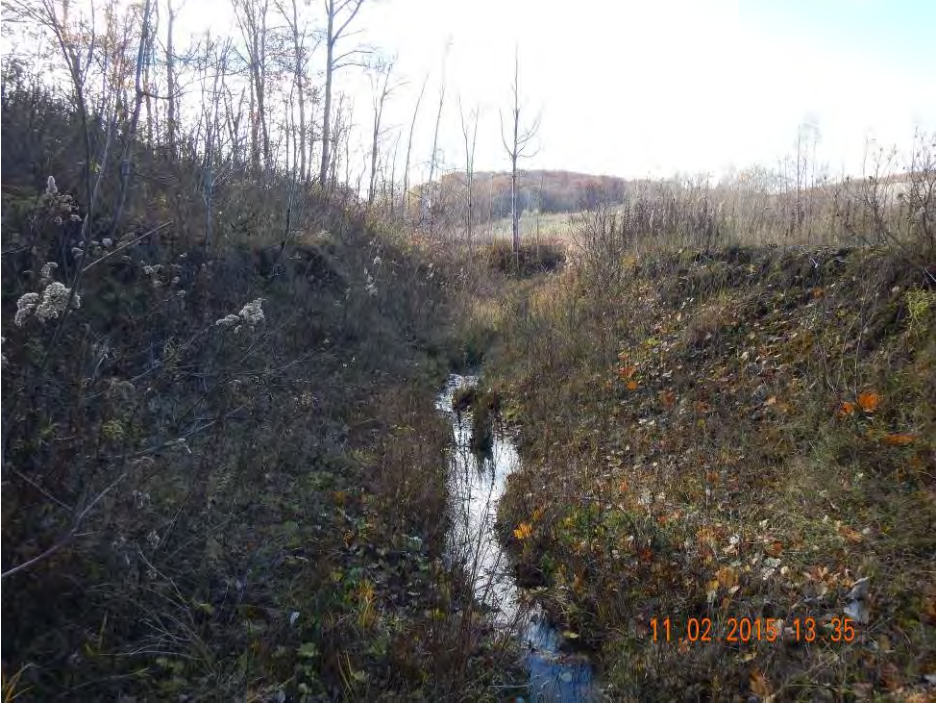
<p><b>EPC-2:</b> Channel viewed in the downstream direction towards end of reach.</p>	
<p>Photo 8</p>	 
<p><b>EPC-1:</b> Mid-reach channel viewed in the downstream direction. Note the limited channel definition and lack of morphological variability, and confinement between valley walls.</p>

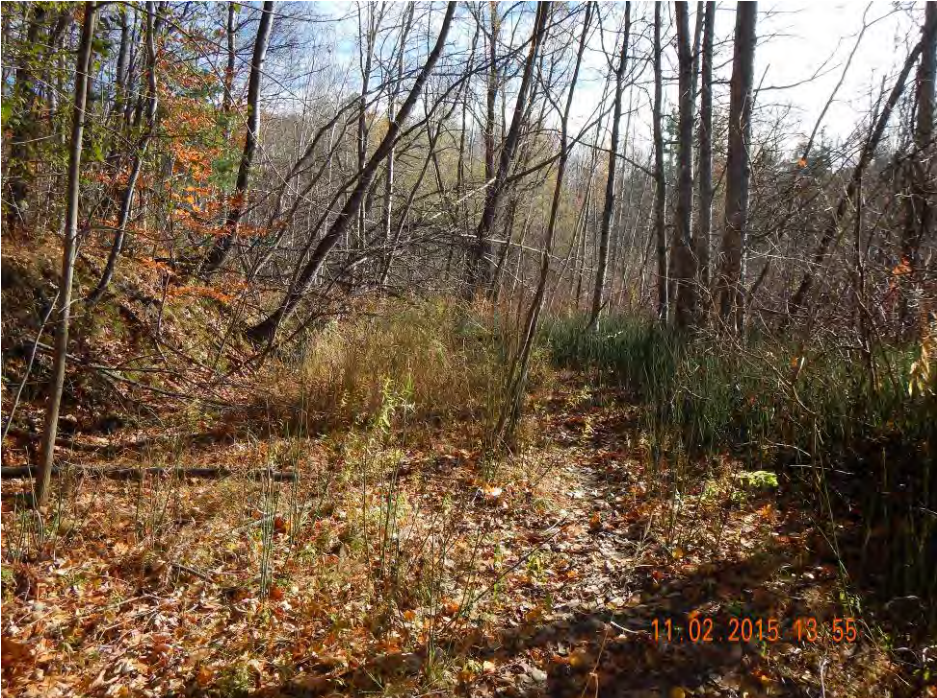
Photo 9

<p><b>EPC-1:</b> Channel viewed downstream towards downstream end of reach. Note the absence of flow and limited channel definition.</p>	
Photo 10

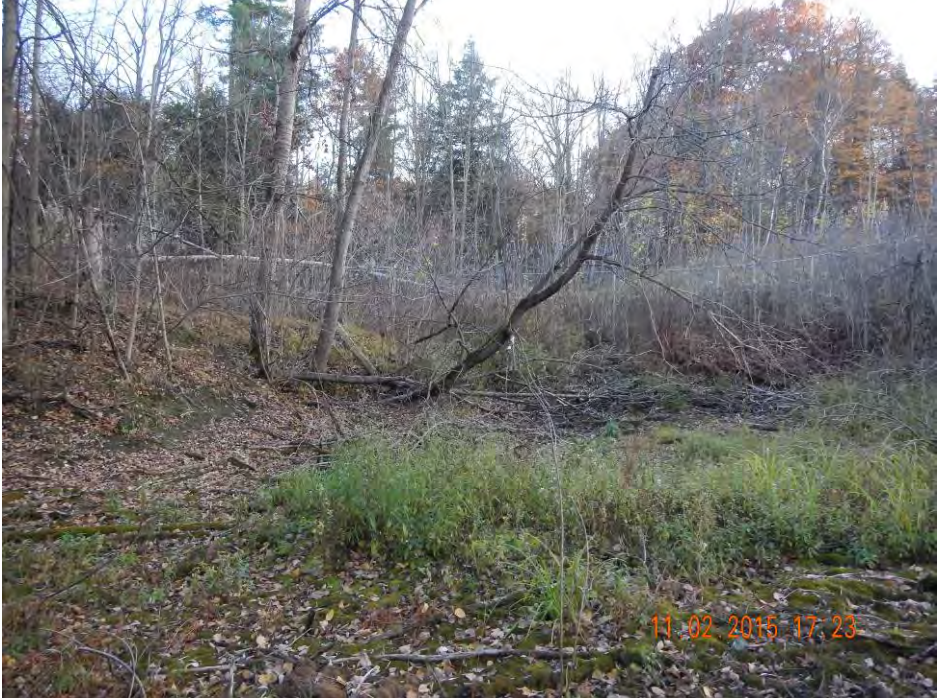
<p><b>EPC-1:</b> Wetland at property line with raised pipeline in background (see fence line). No culvert was found.</p>

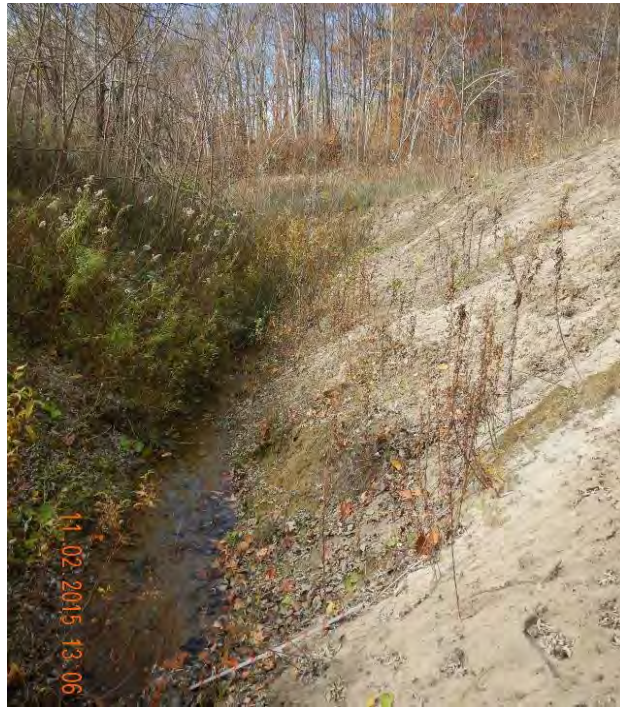
Photo  
1

**EPC-3:** Near upstream extent of reach, viewed upstream. The channel was confined by sandy valley wall to the east and a vegetated valley wall to the west.

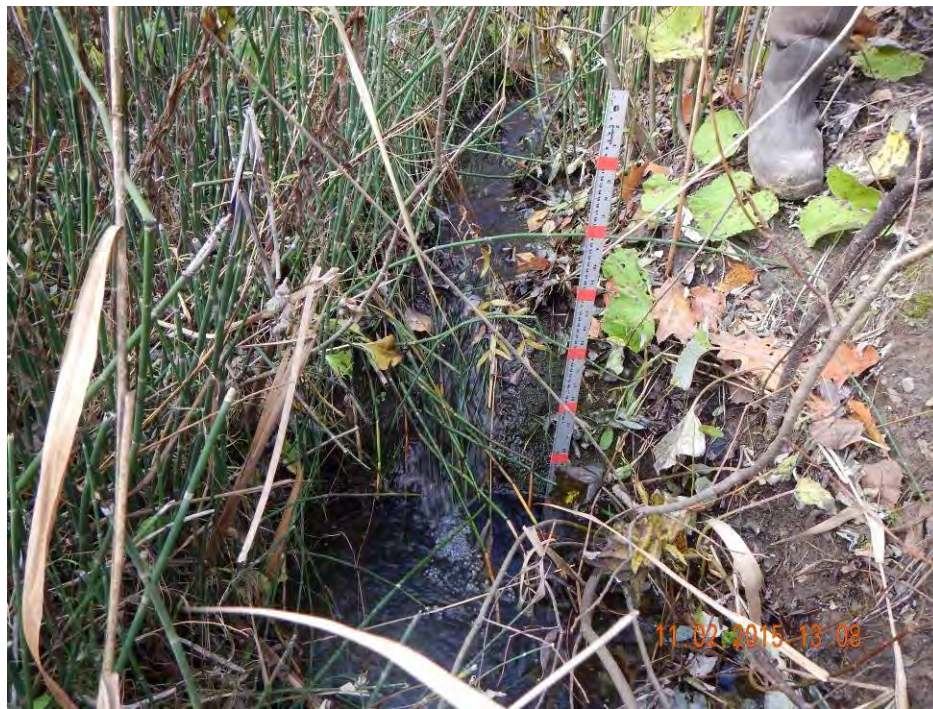
Photo  
2

**EPC-3:** Mid-reach viewed upstream at a knickpoint.

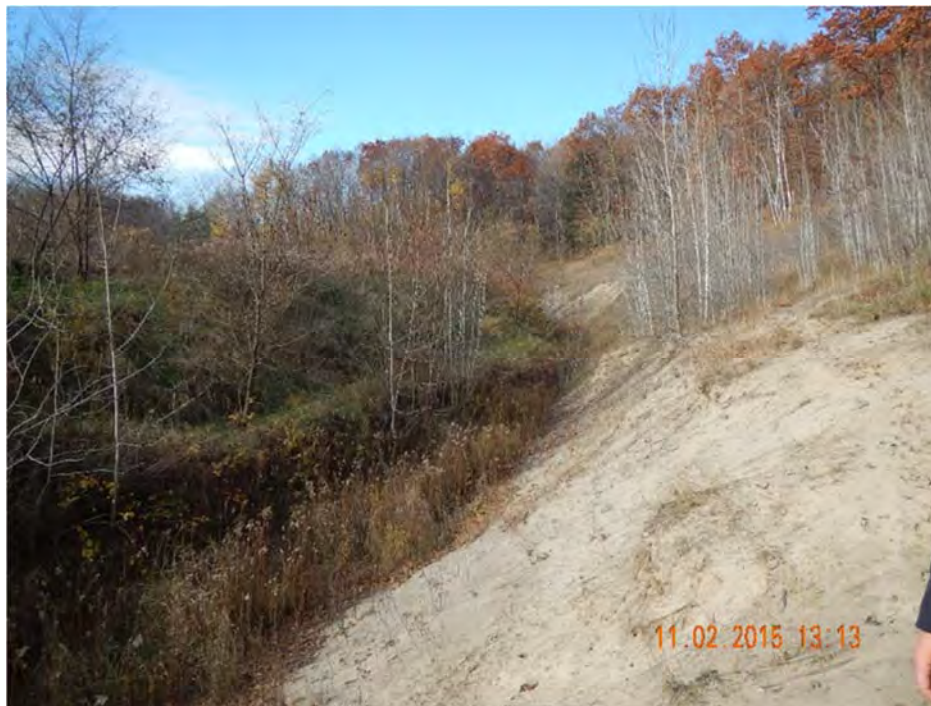
Photo  
3

**EPC-3:** Reach viewed upstream from downstream end of reach.

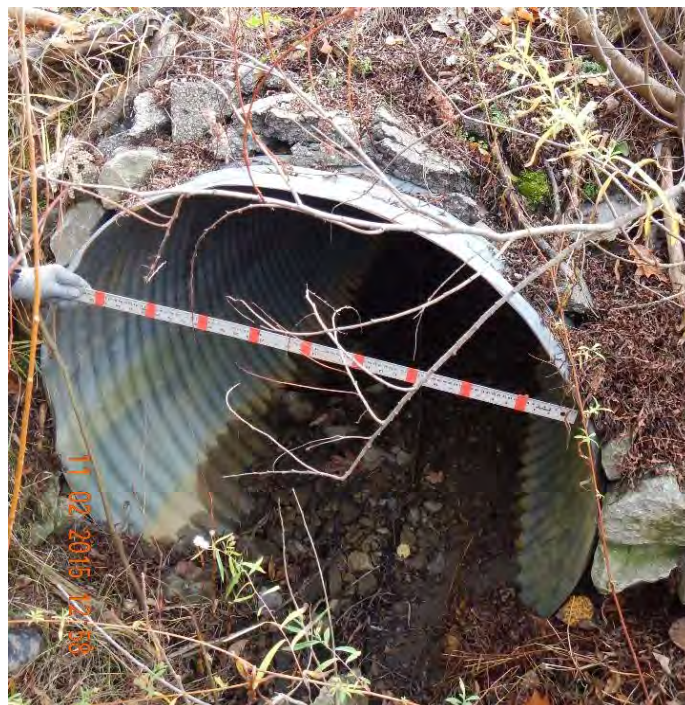
Photo  
4

1200 mm CSP culvert between Reaches EPC-2 and 3.

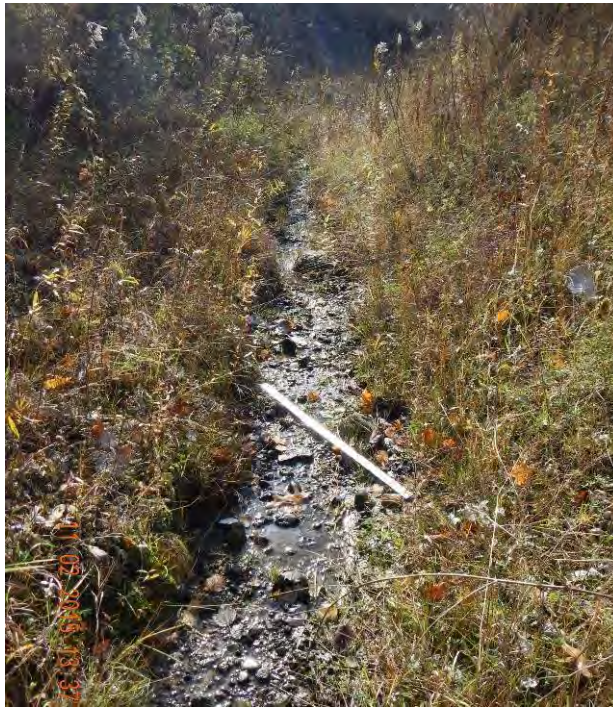
Photo  
5

**ECP-2:** Channel viewed in the downstream direction. Coarse substrate was found mostly in the upstream portion of the reach. Note the channel confinement.

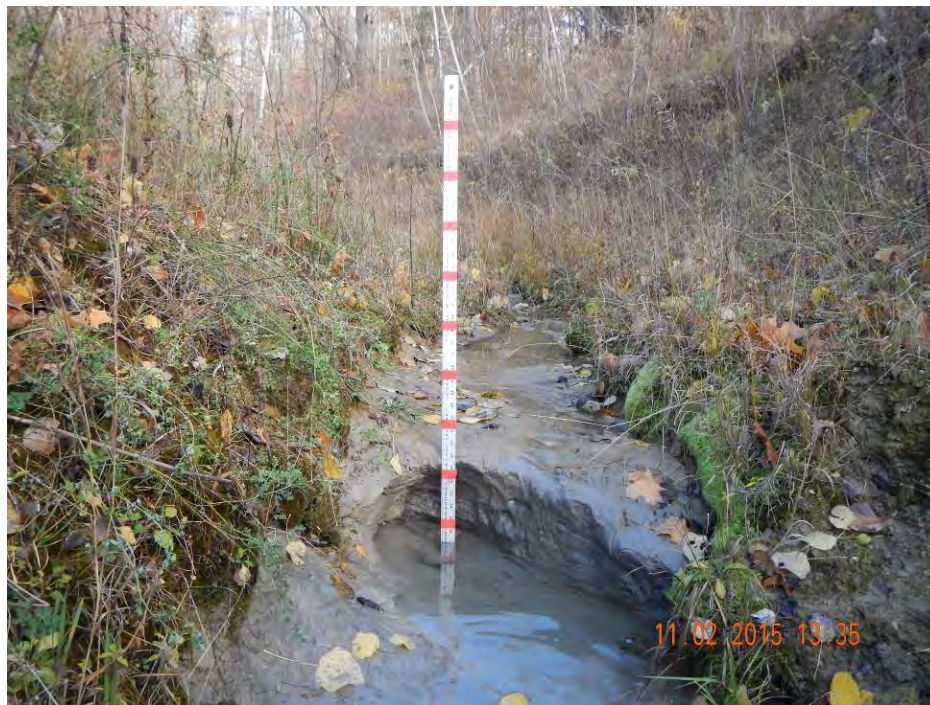
Photo  
6

**EPC-2:** Mid-reach knickpoint in exposed till.

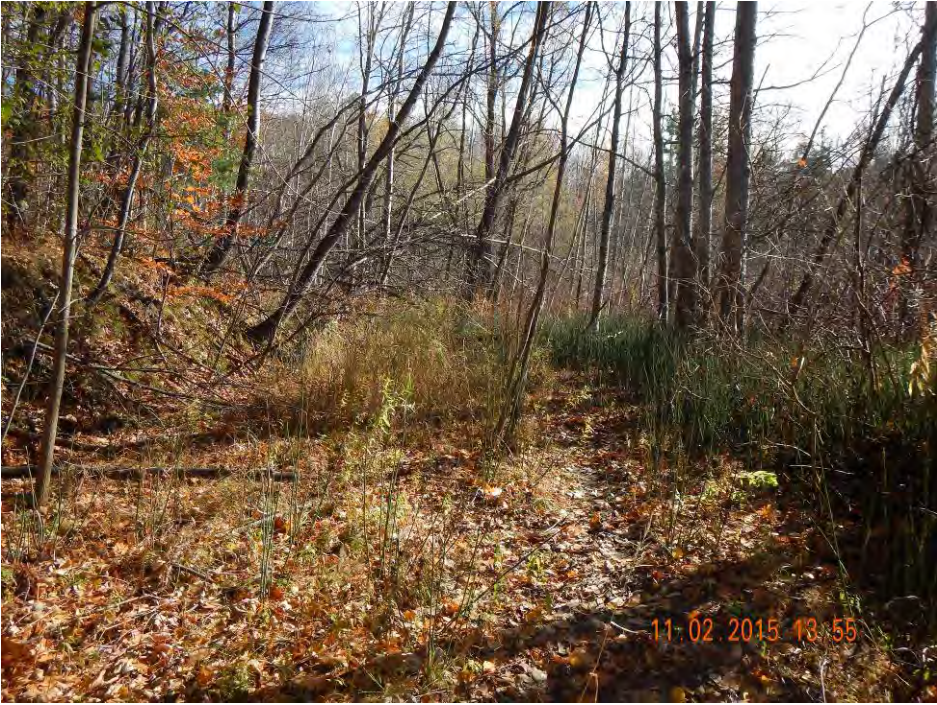
Photo 9

<p><b>EPC-1:</b> Channel viewed downstream towards downstream end of reach. Note the absence of flow and limited channel definition.</p>	
Photo 10

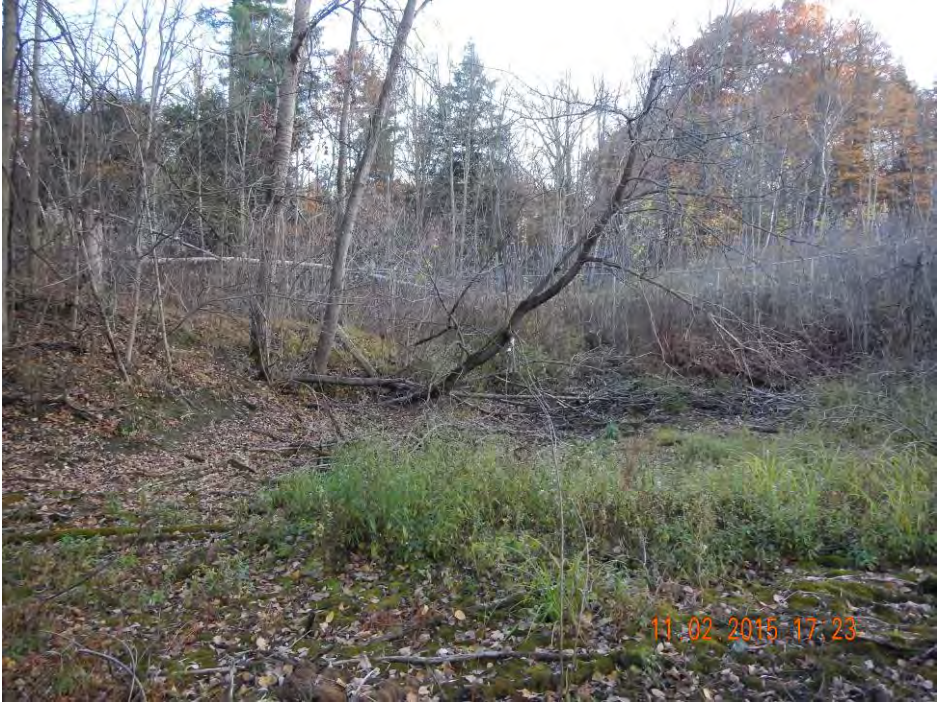
<p><b>EPC-1:</b> Wetland at property line with raised pipeline in background (see fence line). No culvert was found.</p>

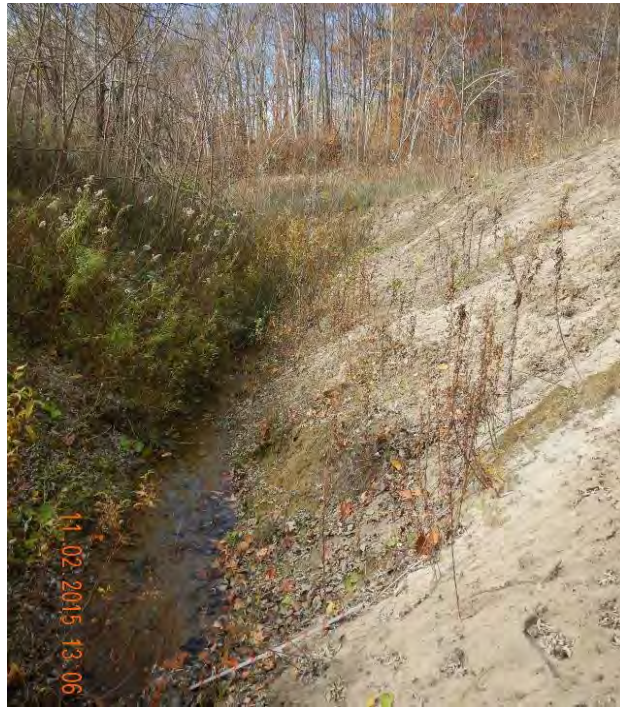
Photo  
1

**EPC-3:** Near upstream extent of reach, viewed upstream. The channel was confined by sandy valley wall to the east and a vegetated valley wall to the west.

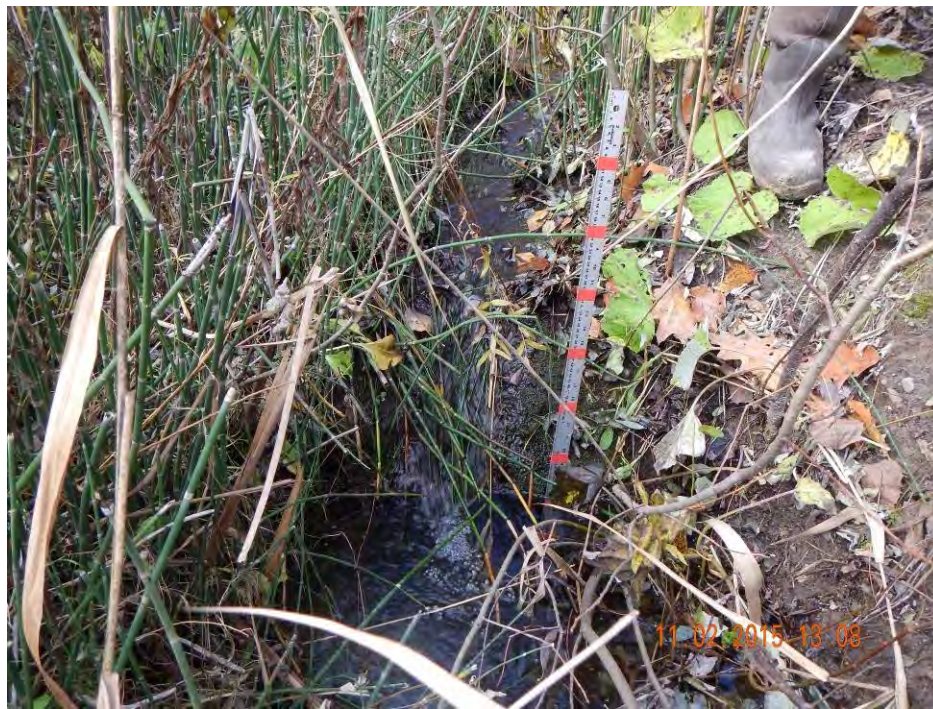
Photo  
2

**EPC-3:** Mid-reach viewed upstream at a knickpoint.

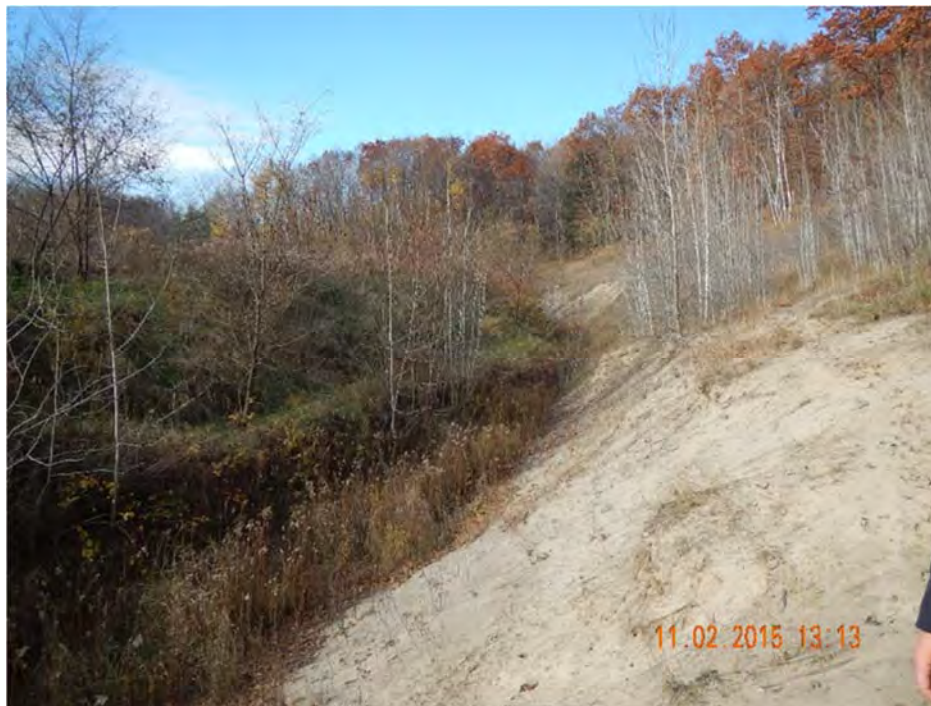
Photo  
3

**EPC-3:** Reach viewed upstream from downstream end of reach.

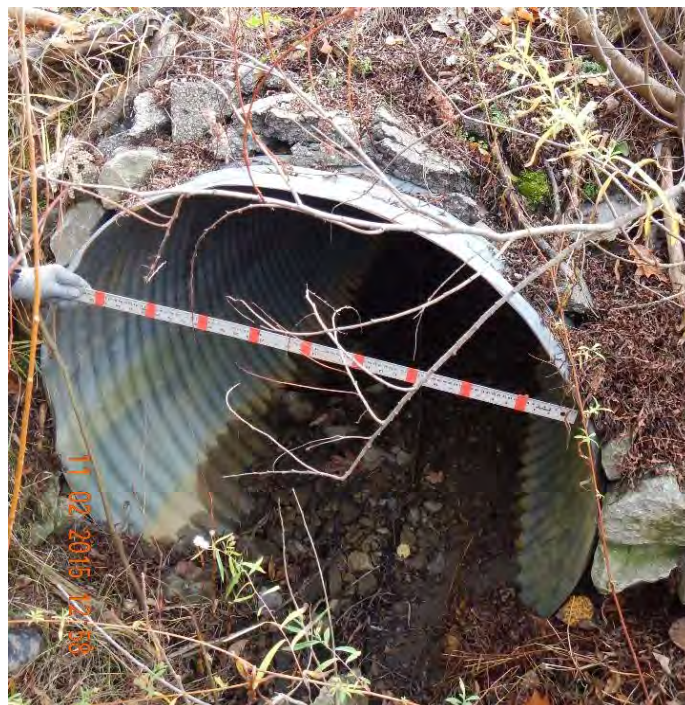
Photo  
4

1200 mm CSP culvert between Reaches EPC-2 and 3.

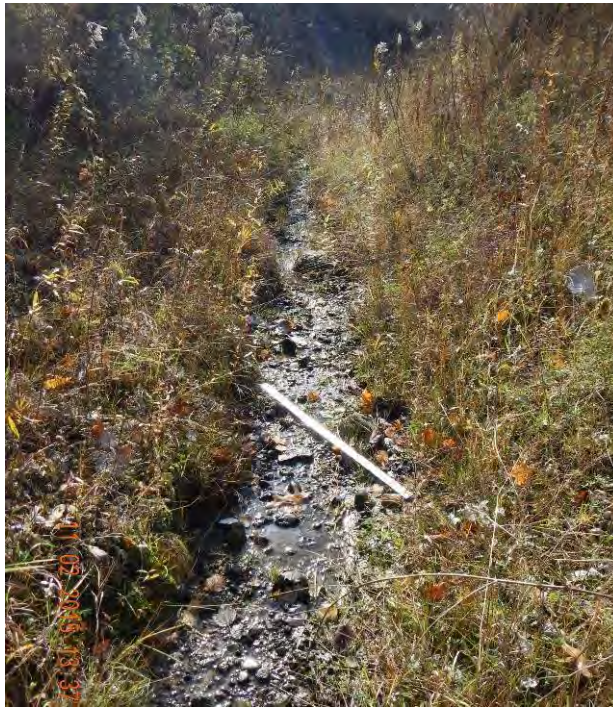
Photo  
5

**ECP-2:** Channel viewed in the downstream direction. Coarse substrate was found mostly in the upstream portion of the reach. Note the channel confinement.

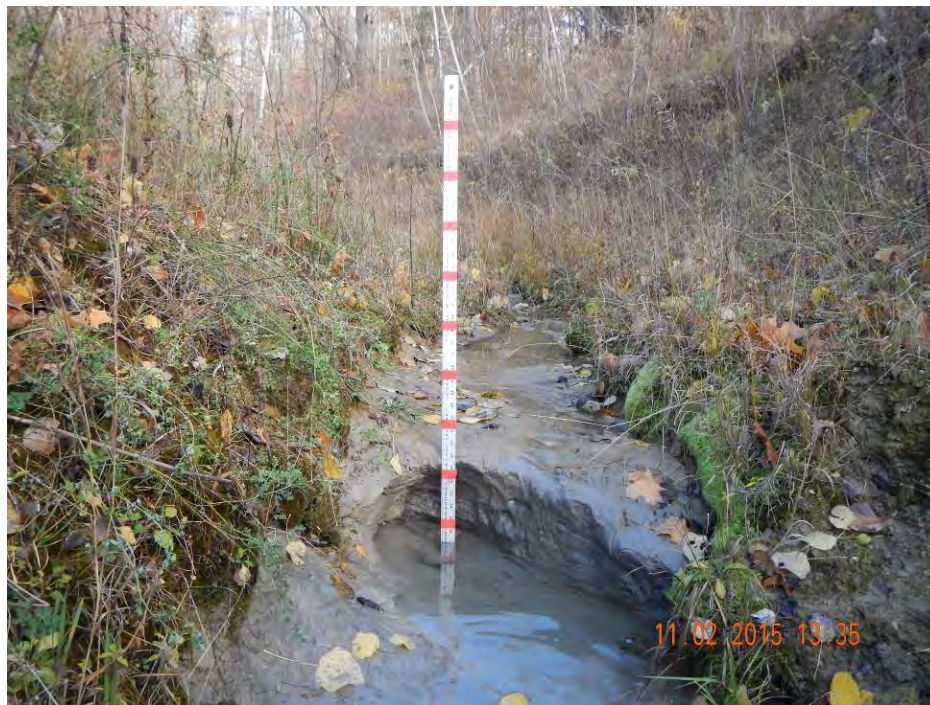
Photo  
6

**EPC-2:** Mid-reach knickpoint in exposed till.

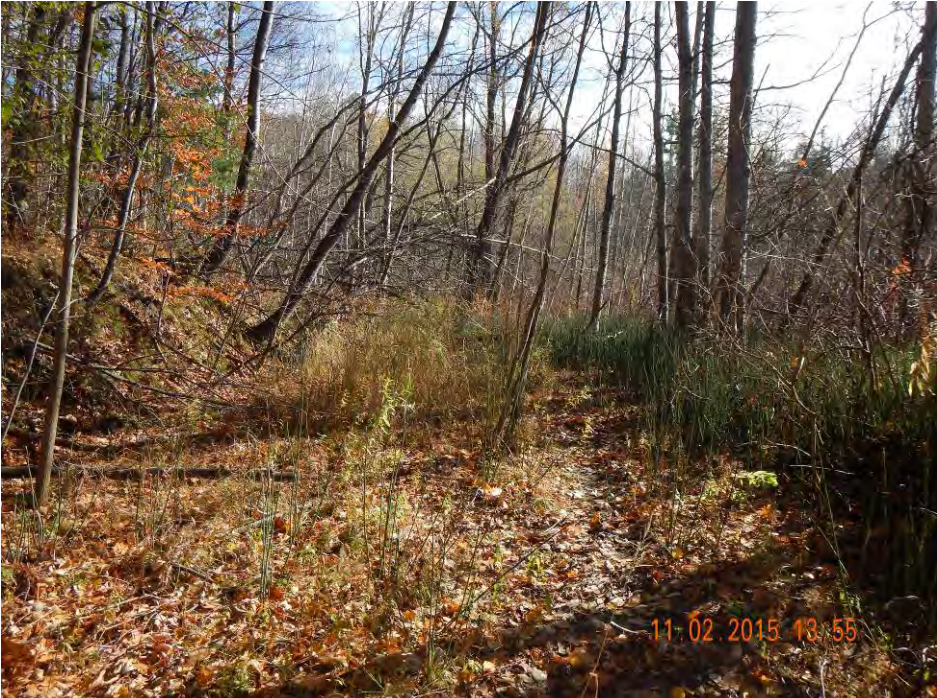
Photo 9

<p><b>EPC-1:</b> Channel viewed downstream towards downstream end of reach. Note the absence of flow and limited channel definition.</p>
Photo 10

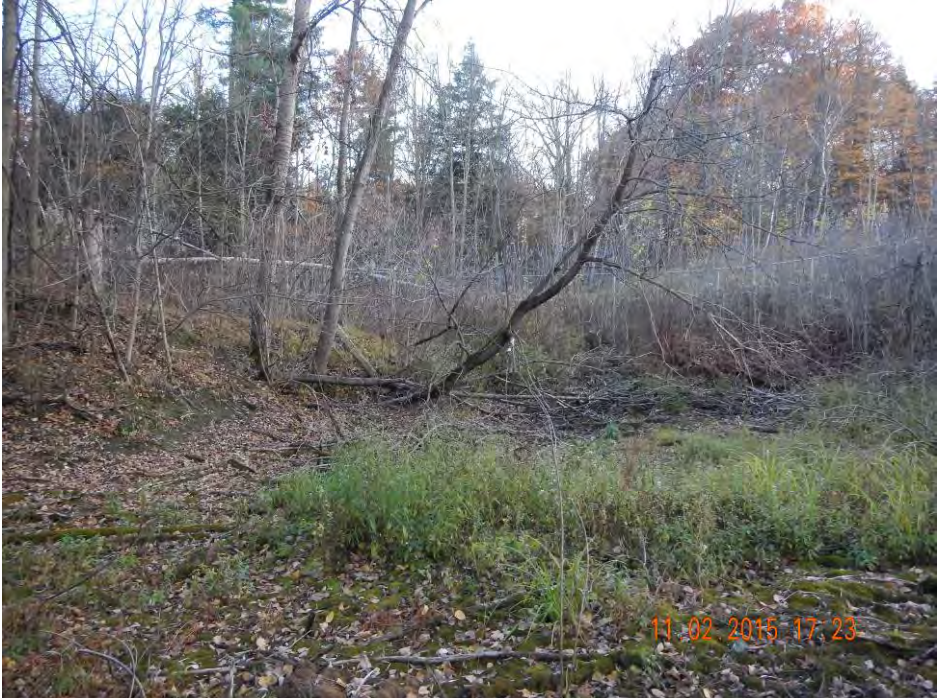
<p><b>EPC-1:</b> Wetland at property line with raised pipeline in background (see fence line). No culvert was found.</p>
